SHORE EROSION STUDY

SHORELINE EROSION AND BLUFF STABILITY

ALONG LAKE MICHIGAN AND LAKE SUPERIOR

SHORELINES OF WISCONSIN

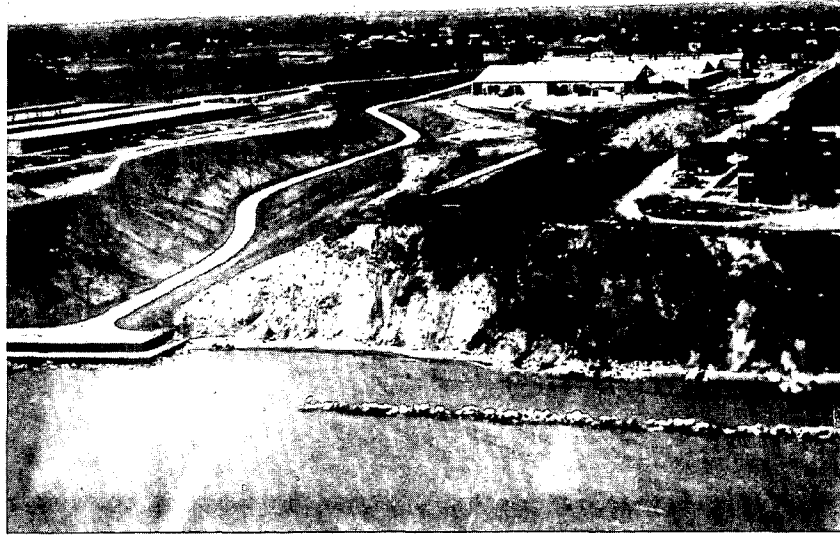
Figure 8. Oblique aerial photograph showing the effect of a breakwater. Note vegetated slope behind the breakwater and active erosion just to the left (south) of the breakwater. Location is T. 5 N., R. 22 E., Section 24, Reach 7, Milwaukee County (oblique R-21, 34).

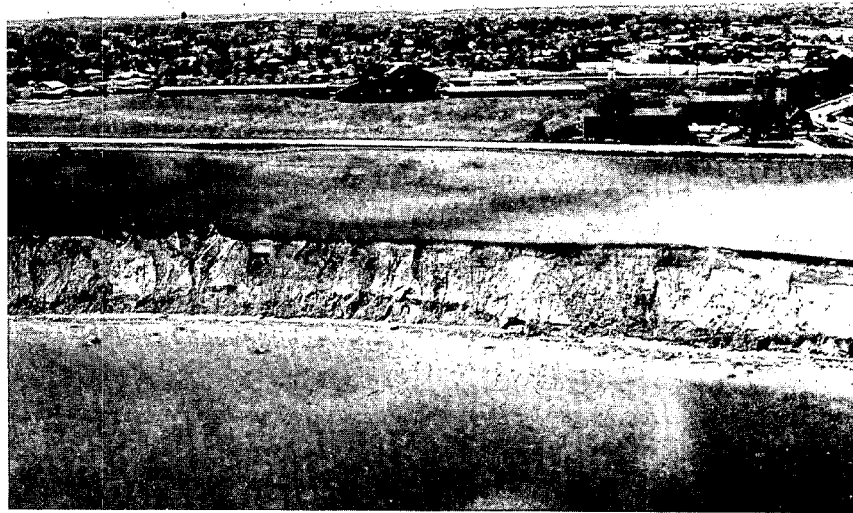
Figure 21. Oblique aerial photograph of the bluff showing beach littered with boulders where till 1 is exposed at the base of the bluff. Location is T.6N., R.22E., Section 24, Reach 8, Milwaukee County (oblique R-20, 14).

the state, in Racine and Kenosha Counties, this till is below lake level and the southernmost exposure of the till is just south of the city of Milwaukee in Reach 8, Sections 23 and 24 (see next chapter). Here it is exposed in the lower 10 feet of the bluff where it contributes a great deal of coarse material to the adjacent beach (Fig. 21). North of the city of Milwaukee, till 1 is exposed more commonly near the base of the bluff all the way into Kewaunee County.

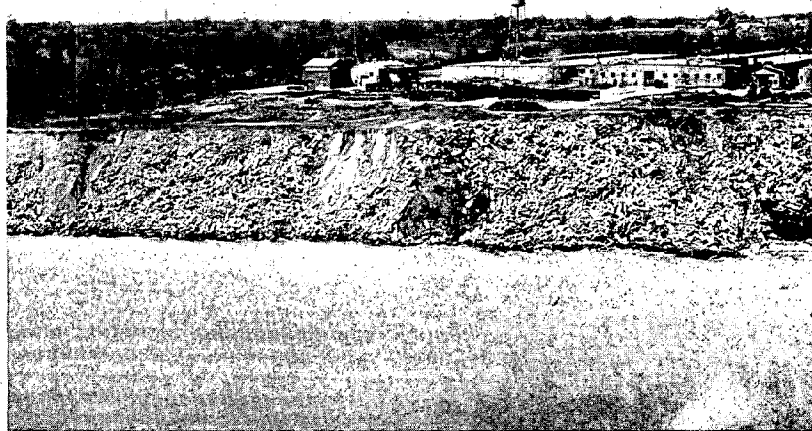
Figure 35. Oblique aerial photograph of the bluff in the northern part of Reach 7. Note the revetment of concrete blocks dumped from the top of the bluff. Location is T.5N., R.22E., Section 24, Reach 7, Milwaukee County (oblique R-22, 2).

is protected by concrete rubble dumped from the bluff top (Fig. 35), and in places the slope has been graded.

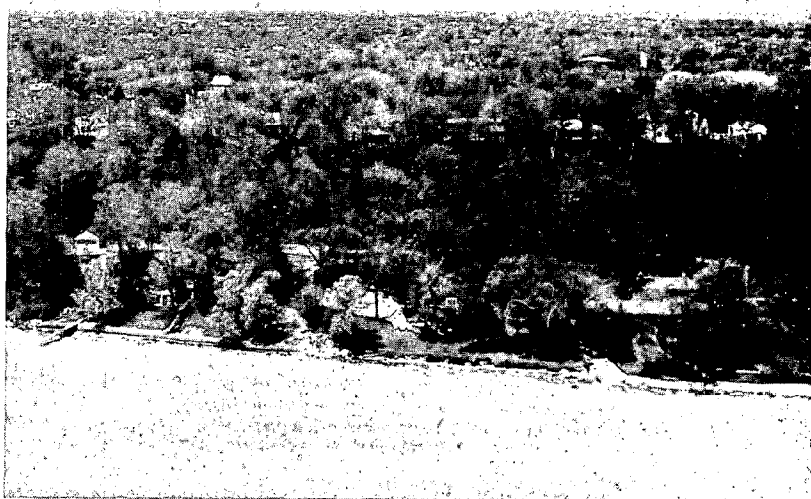
Figure 39. Oblique aerial photograph showing Nipissing Age (605' elevation) terrace. Terrace is protected by revetments and seawalls. The bluff behind the terrace is vegetated and stable. Location is T.8N., R.22E., Section 21, Reach 10, Milwaukee County (oblique R-16, 28).

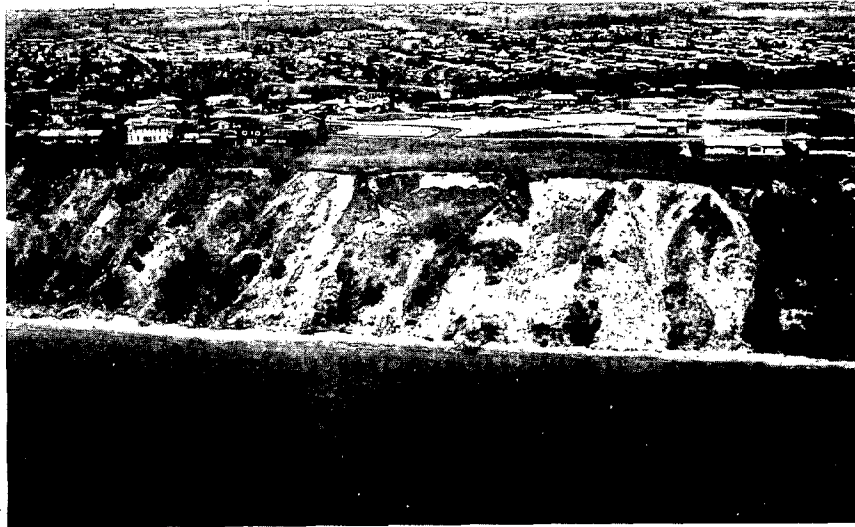
Slope failure within the reach is primarily slumping with a little sliding in the southern half (Fig. 48) and sliding only in the northern half. Many of the slump blocks are vegetated and there are few completely bare slopes, as there are in reaches to the south.

Reach 48. Oblique aerial photograph typical of the bluff in the southern part of Reach 15. Slumping takes place in the upper part of the bluff and shallow slides are more typical of the lower part of the bluff. Location is T.11N., R.22E., Section 22, Reach 15, Ozaukee County (oblique R-12; 8).

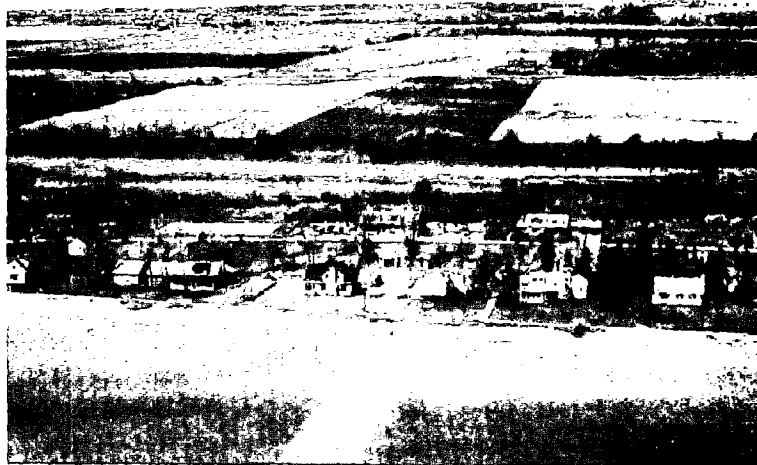
The terrace ranges in width from about 250 feet to 500 feet. Behind the terrace the bluff is about 50 feet high and is entirely vegetated and stable (Fig. 49). Very little stratigraphy is exposed in the terrace and probably much of the terrace material is sand. At the north end of the reach a bedrock point extends into the lake from the terrace (Fig. 50).

Figure 49. Oblique aerial photograph showing terraced areas typical of Reaches 16 and 17. The low bluff behind the terrace is vegetated and stable. Location is T.12N., R.23E., Section 25, Reach 16, Ozaukee County. (oblique 9,14)

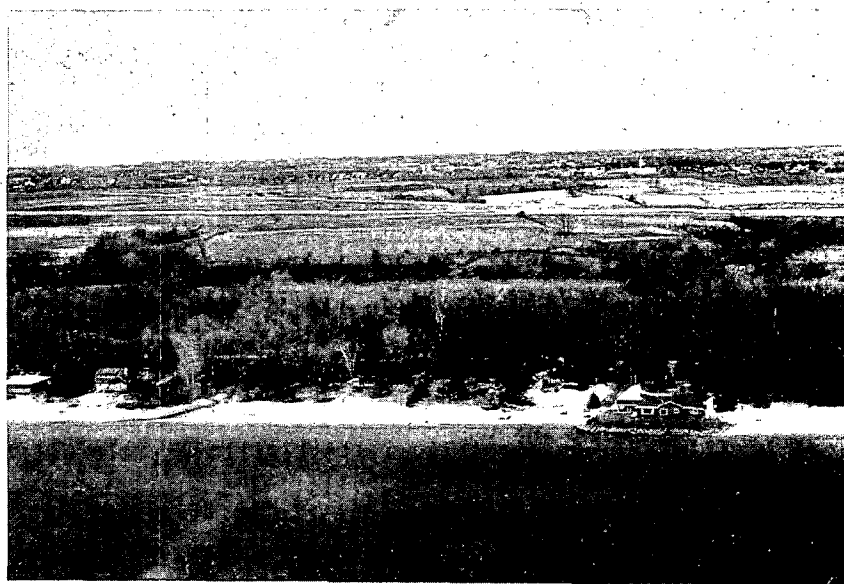
Figure 57 is an oblique aerial photograph showing the general character of the shoreline in Reach 18A. The lack of beach in front of the revetment protecting the home in the foreground demonstrates the retreat of the shoreline in the reach.

Figure 57. Oblique aerial photograph showing the general character of the shoreline in Reach 18A. The absence of beach in front of the revetment protecting the home in the foreground demonstrates the retreat of the shoreline along this reach. (oblique 8,19)

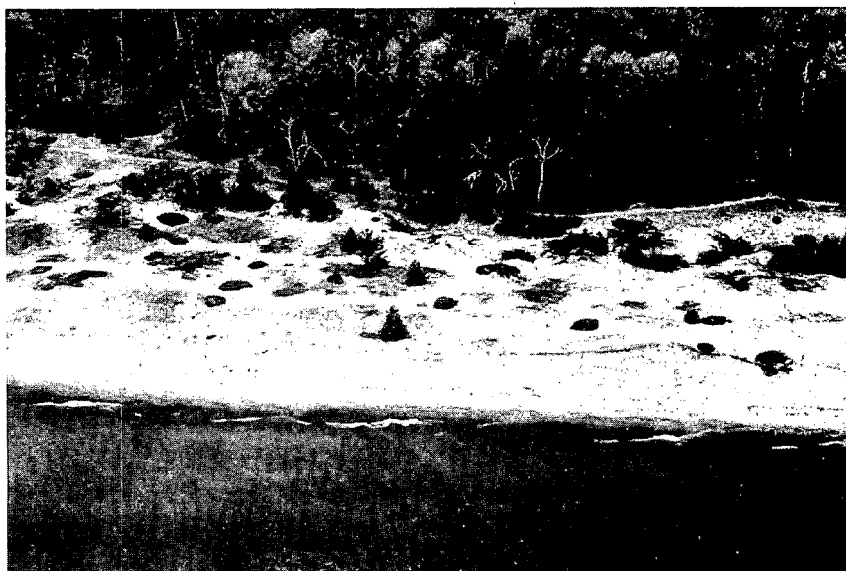
Figure 59. Oblique aerial photograph showing typical undeveloped shoreline in Reach 18C. (oblique 4,19)

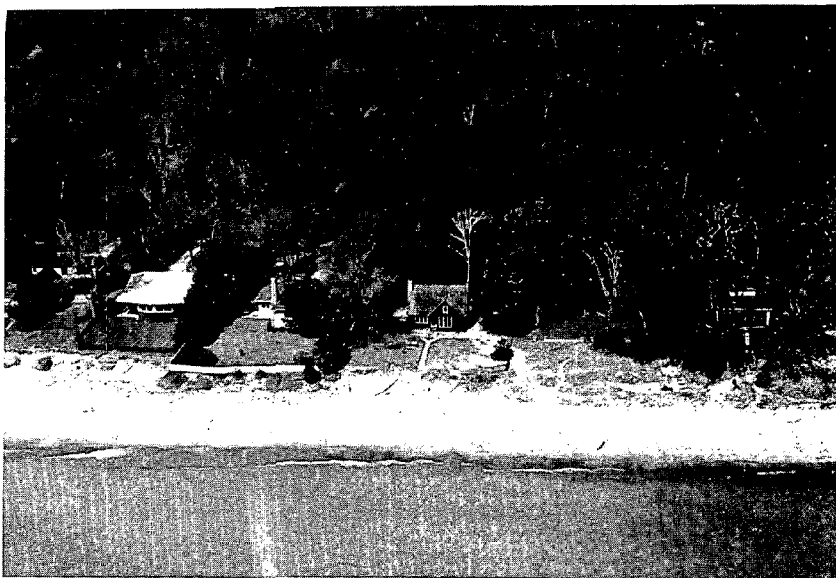
Figure 60. The southern portions of Reach 19 are typified by year
around residences fronted by sand beaches along the terrace.
(oblique 4,6)

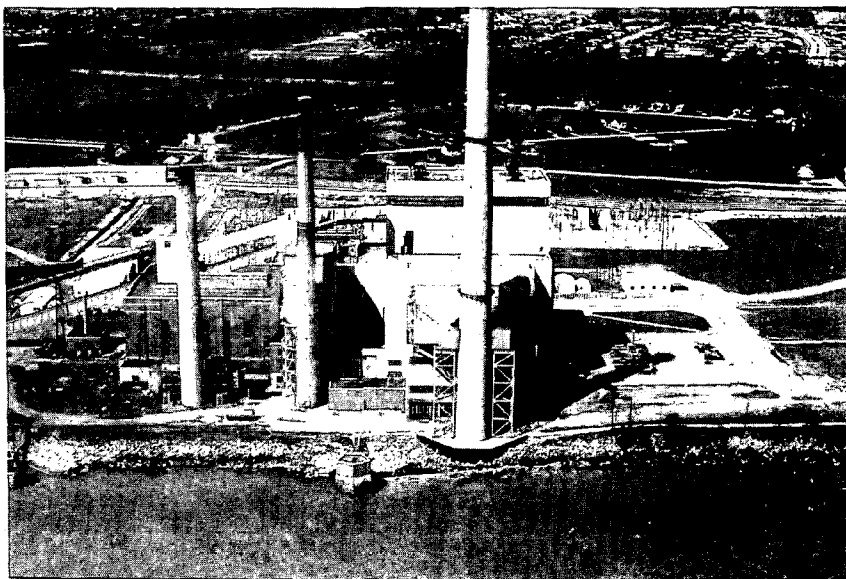
Figure 61. In the central portion of Reach 19, the ground elevation increases and land use is largely industrial.
(oblique 3,19)

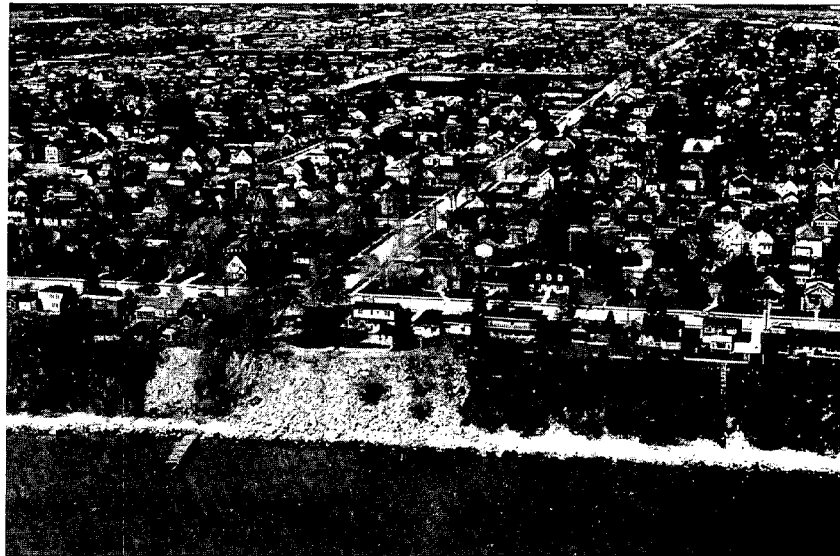
Figure 62. The northern portion of Reach 19 is an area of well-protected high bluffs and is densely populated. (oblique 3,9)

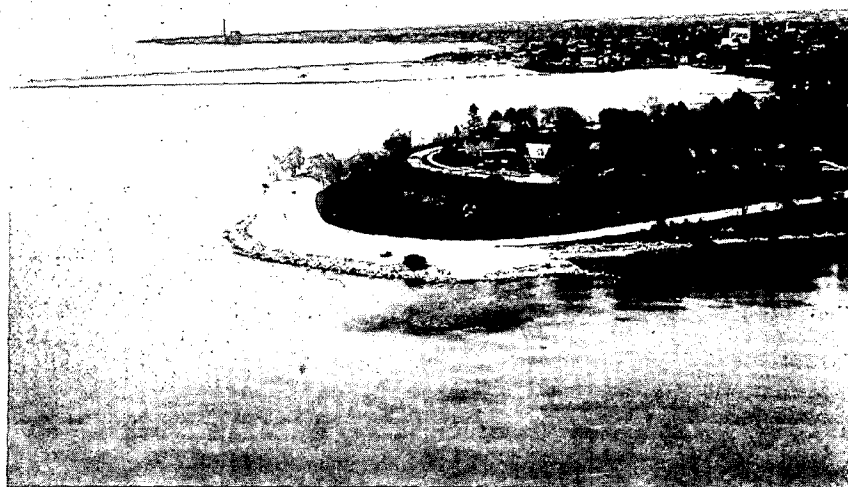
Near the southern boundary of the reach bedrock is very shallow or exposed in the nearshore area. This body of dolomite at or near the water surface is known as the "Sheboygan Reef". The promintory, Sheboygan Point, that marks the southern reach boundary is almost certainly due, in part, to the protection provided by this natural breakwater. These features are shown on Figure 64.

Figure 64. Oblique aerial photograph of Sheboygan Point at the southern boundary of Reach 21. The disturbed water in the foreground is the result of waves breaking on the exposed dolomite of the Sheboygan Reef. (oblique 53,6)

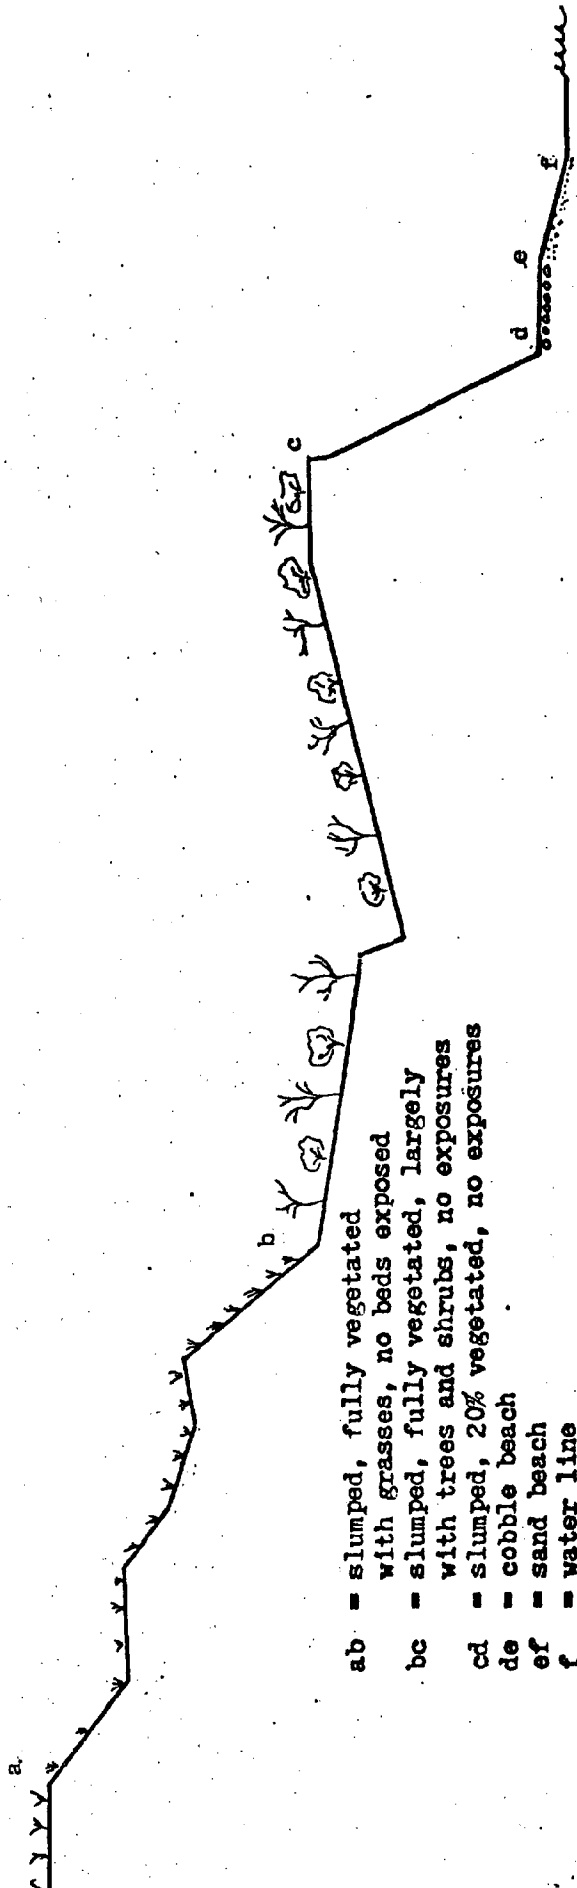
and are more than 100 feet from scarp to toe. This dramatic change in mode of failure appears to coincide with the pinching out of the lacustrine beds between the two tills. A profile at right angles to the bluff in a very similar area in Reach 23 is shown in Figure 67 and the contrasting failure modes are shown on Figures 68 and 69.

Figure 67. Cross-section through an area of large scale sequential slumping. Slope failures of this type are typical of the northern portions of Reach 22 and most of Reach 23.

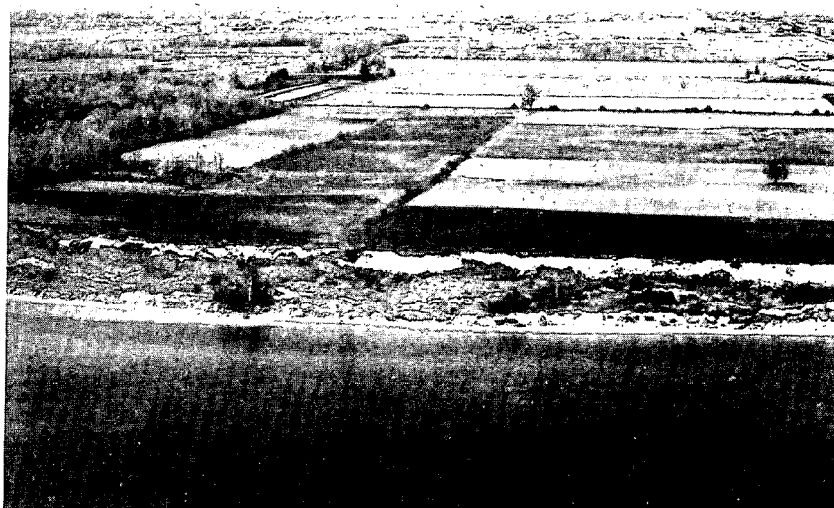
Figure 69. Oblique aerial photograph showing the large scale sequential slumping typical of the northern portions of Reach 22. (oblique 51,25)

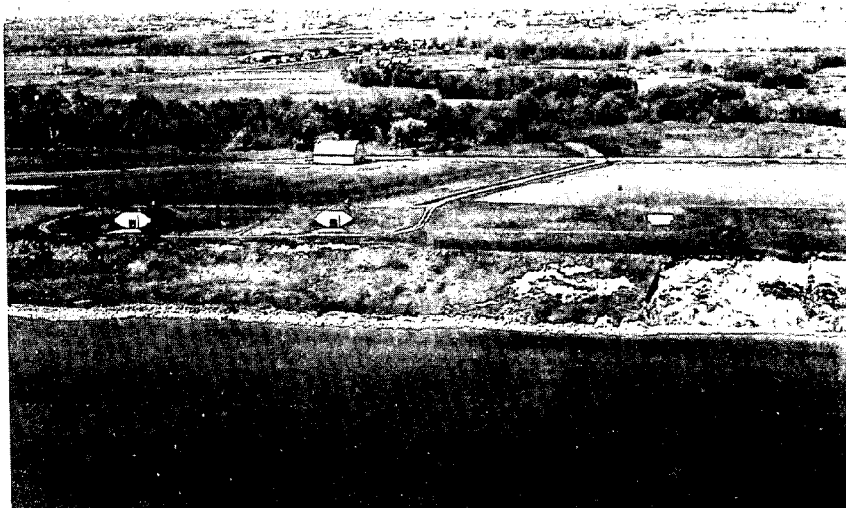
Figure 71. Oblique aerial photograph showing the contrast between the unprotected shoreline shown at the right and the largely stable and erosion free slope lying behind a well designed and constructed stone revetment on the left. Reach 23, Sec. 15, T. 16 N., R. 23 E. (oblique 51,20)

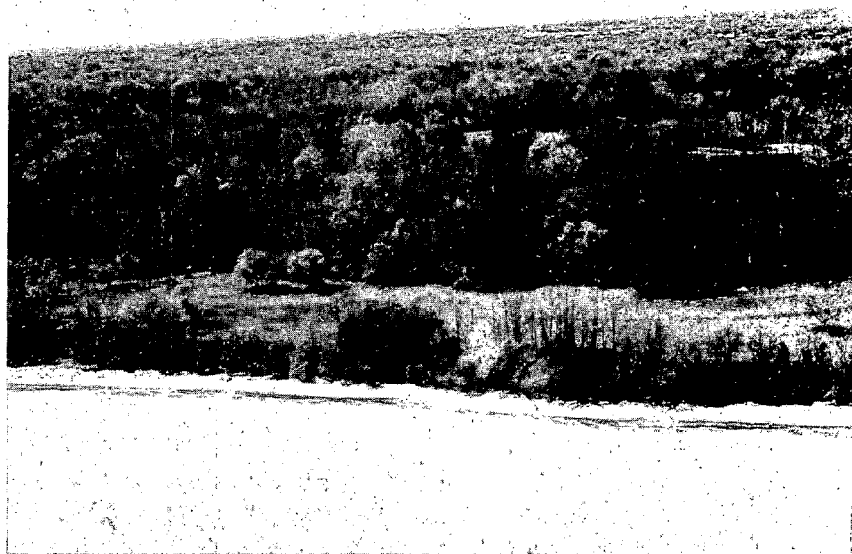
Figure 72. Oblique aerial photograph of a portion of the terrace that lies in southern Reach 24.

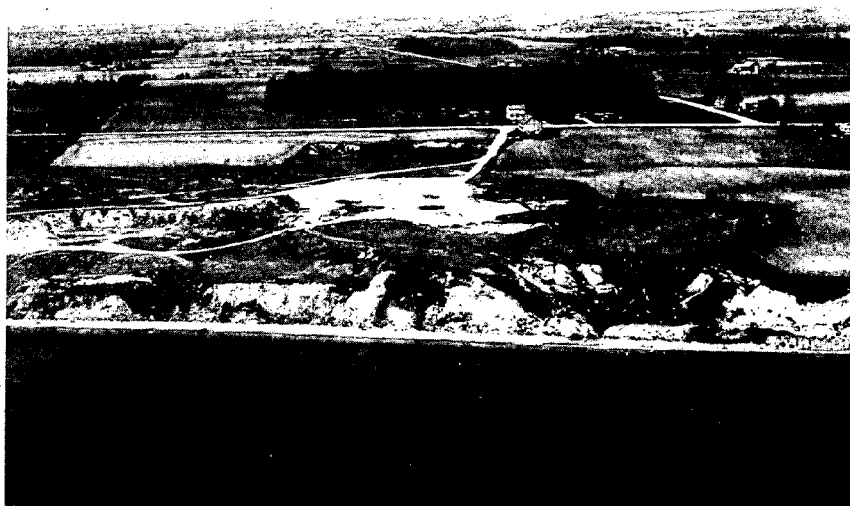
Figure 73. Oblique aerial photograph showing gravel pits in a body of pitted outwash in Sec. 24, T. 18 N., R. 23 E. The floor of the pit in the foreground is at the contact between the outwash and the underlying till 3A. (oblique 48,16)

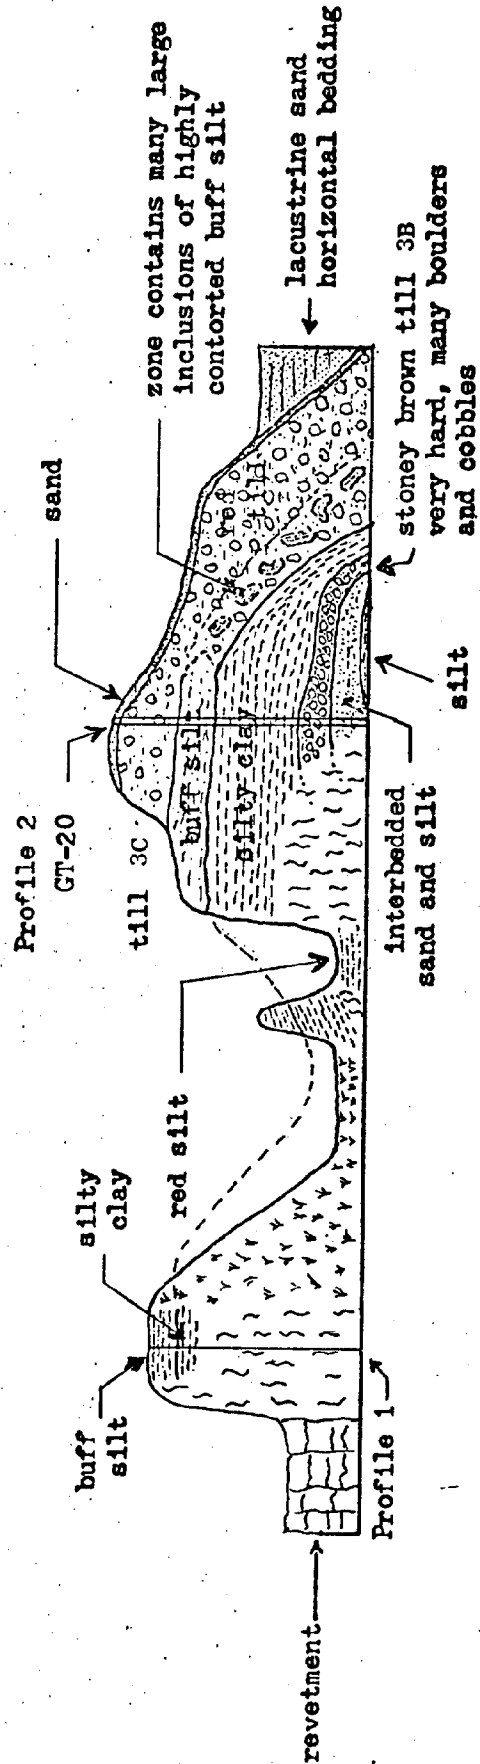
The bluffs in section 16 rise to a maximum height of about 30 feet above the beaches. In the southwestern portion of the shoreline in the section, very little stratigraphy is exposed due to heavy vegetative cover and the large amount of slumped silt that covers the greater part of even actively eroding areas. About 3 feet of bluff silt over 2 feet of silty clay was the maximum section observed in the southwestern portion of section 16 (Fig. 74).

Figure 74. Generalized longitudinal profile of Sec. 16, T. 19 N., R. 24 E., Reach 27.

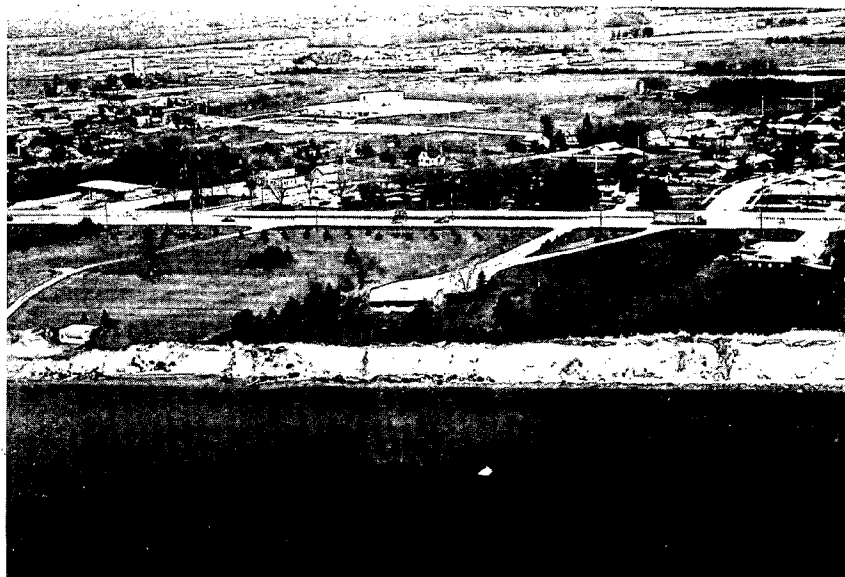
Figure 75. Oblique aerial photograph showing a portion of the high bluff area in Sec. 16, T. 19 N., R. 24 E., Reach 27.

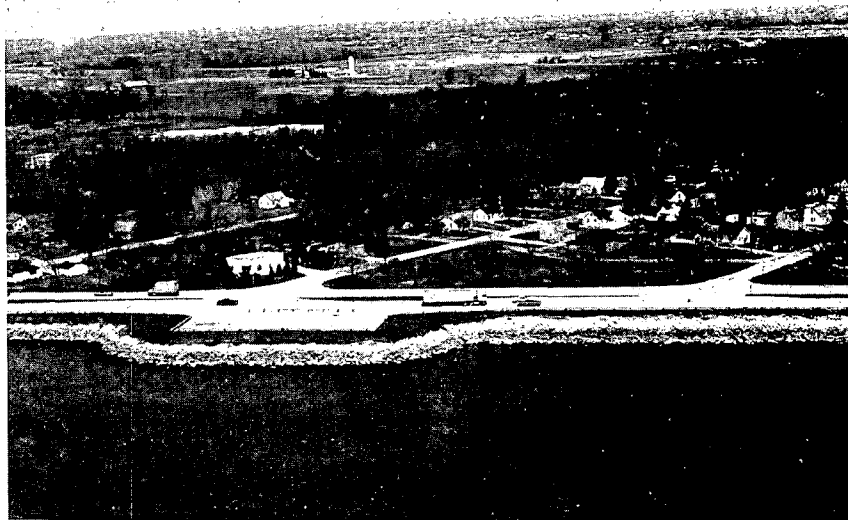
Figure 76. Oblique aerial photograph showing a typical heavily protected segment of the shoreline in Reach 27.

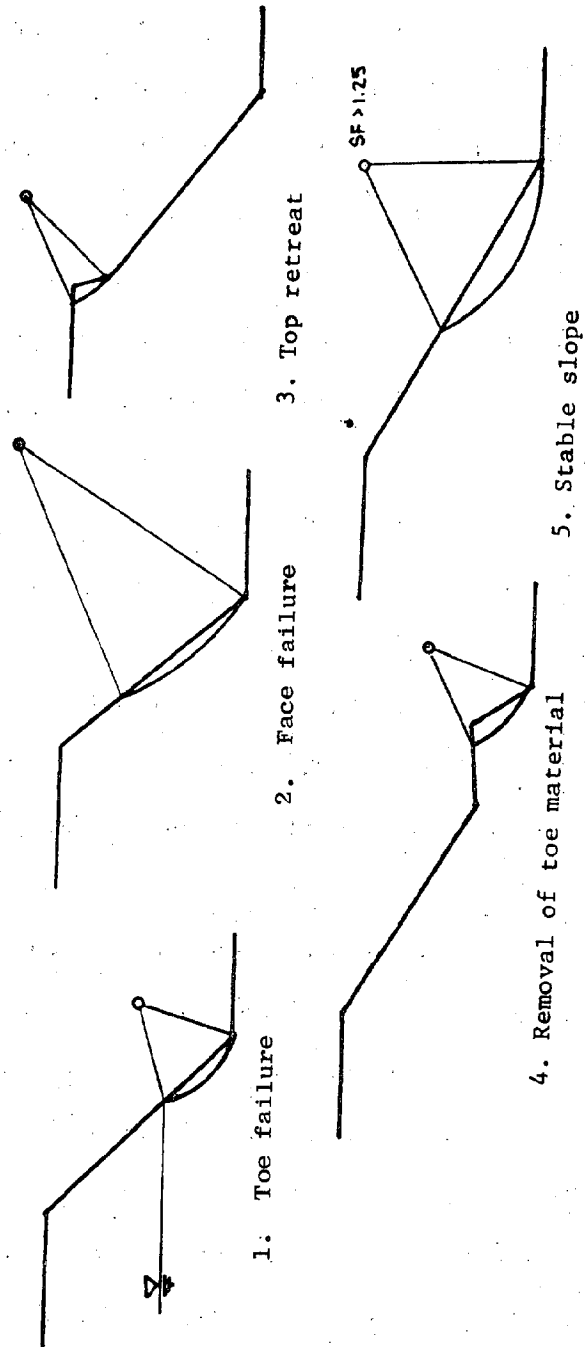
The stability analysis of the bluffs covered in this study yielded a number of distinct types of failure processes, which are shown schematically in Fig. 87. These failure types shall be referred to as follows:

4. Removal of toe material. In mostly stable bluff, where slope debris (slump blocks) were accumulated at the toe of the bluff, the failure circle indicated the removal of this toe material, while not affecting the stability of the bluff as a whole.

5. Stable slopes. Minimum Safety Factors for stable bluffs were either for shallow or deep-seated circles, but indicated no tendency to fail.

Figure 87. Types of slope failure and face configuration.

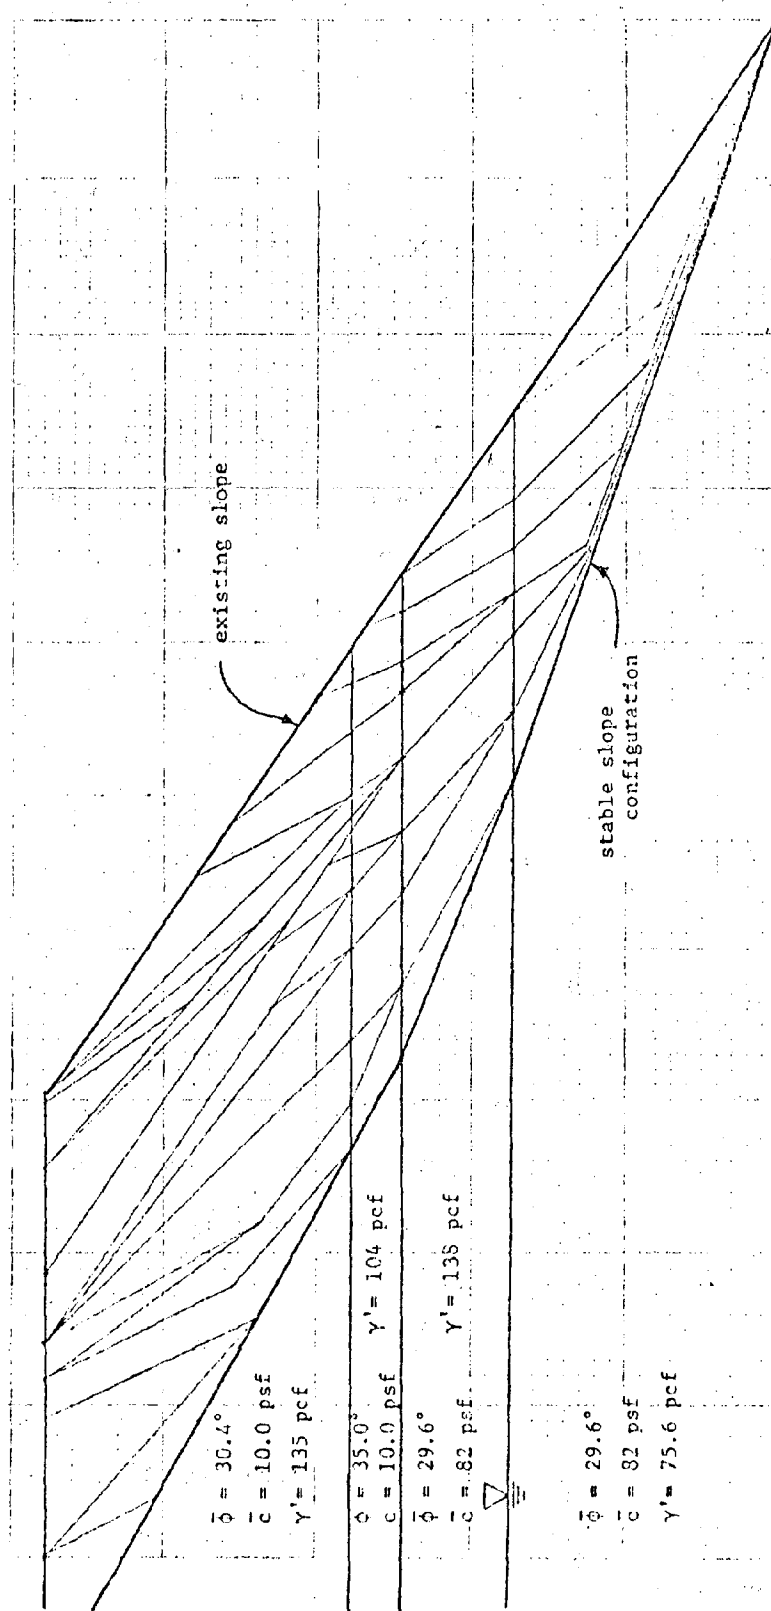
1. Critical circle criterion. According to this criterion, the process of failure of the bluffs is seen to follow a succession of small, rotational slides which progress from the toe to the top of the bluff. (Edil & Vallejo, 1977). An example of this was investigated at borehole GT-6, and outlined in Fig. 88. Each time a critical circle with a Safety Factor of less than one was obtained, failure was assumed to occur, and the slumped material was assumed to be removed by waves and surface erosion. The resulting profile was re-analyzed, and each consecutive failure allowed to occur. This sequence of successive failures showed a pro-

Figure 88. Slope evolution example showing sequence of successive failures at Profile 2, Section 28, T9N.

gression of small, surficial slides which progressed up the face of the bluff, continuing until a Safety Factor greater than unity was encountered, and a stable slope configuration was reached.

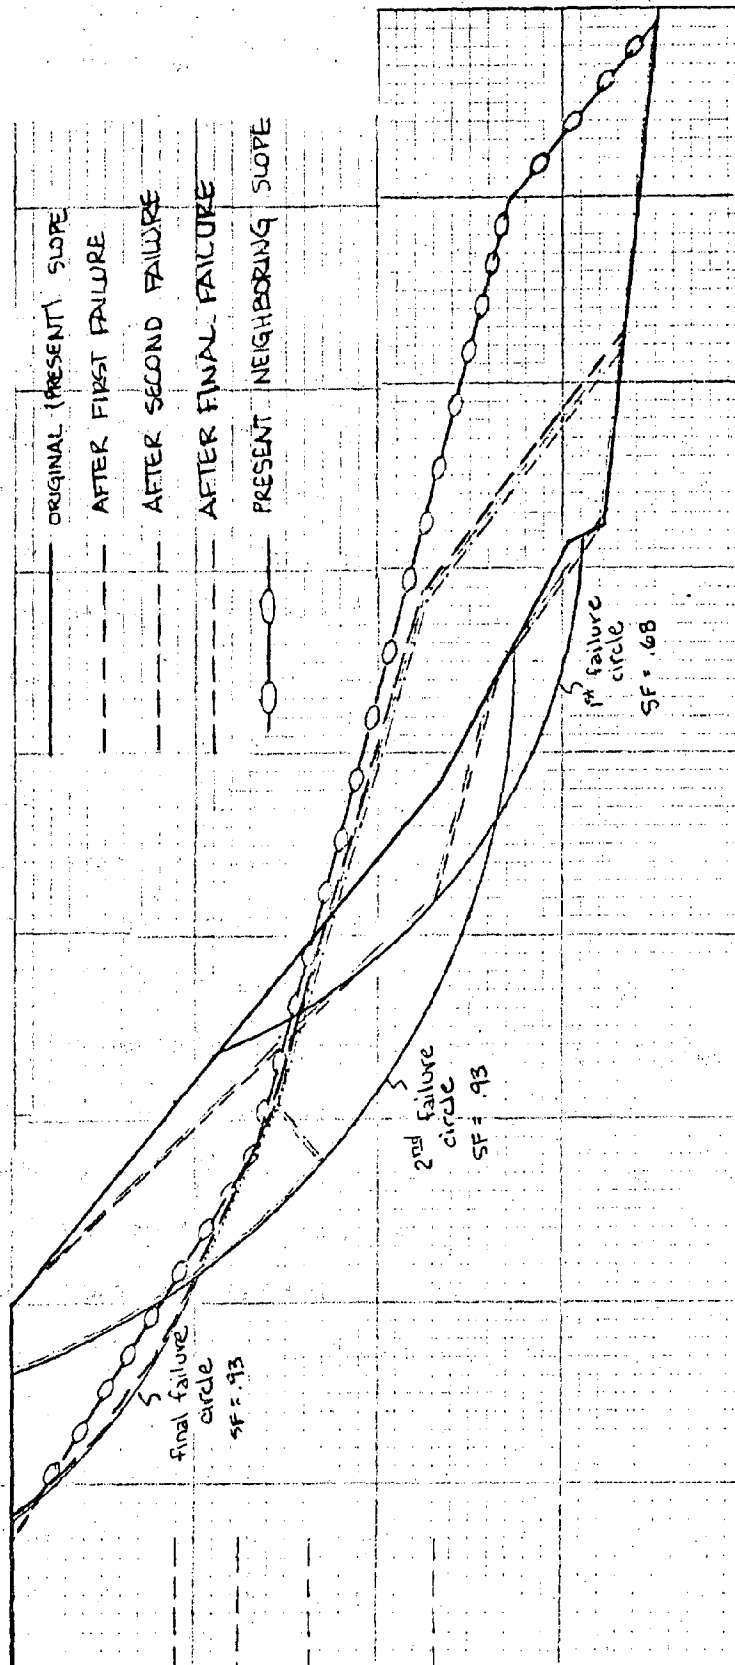
2. Unstable circle criterion. An example of the unstable circle criterion was studied for a slope in Reach 13; Profile 2, Sec. 33, TION, and is outlined in Fig. 89. Failure was assumed to occur throughout the zone where the computer analysis indicated a Safety Factor less than unity, for each failure circle try. This zone was bounded by the largest failure circle with a Safety Factor less than one, which was then assumed to rotate, but not to be completely removed. This criterion resulted in failures which also progressed up the slope, but each failure was of much larger extent, and a stable slope configuration was reached after just three failures.

Figure 89. Slope evolution model showing series of progressive failures using the "unstable circle" criterion (profiles 1 and 2, Section 33, T10N).

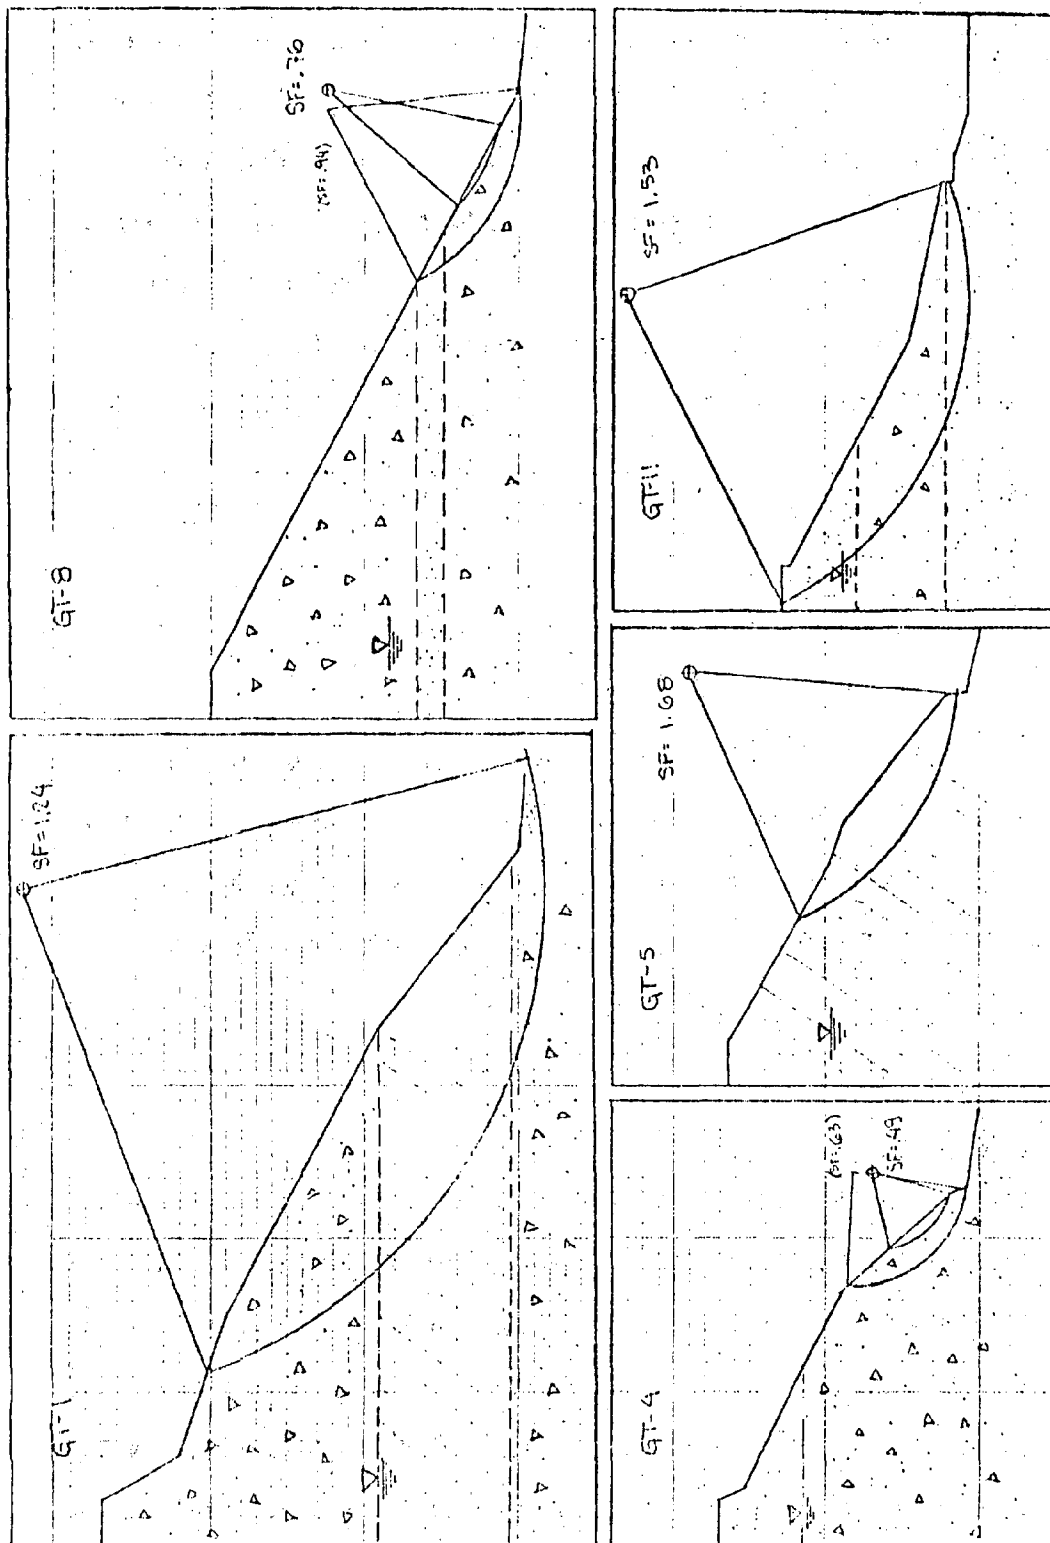
Figure 90. Profiles at geotechnical sites showing critical failure circles. See Fig. 94 for meaning of symbols.

Safety Factors vary considerably. The profiles at boreholes GT-5 and GT-1 (Fig. 90) both have lacustrine clay deposits over a significant portion of the slope, and the safety factor is high in both cases. Higher cohesion may, however, make undrained failure critical, particularly where artesian pressures are present.

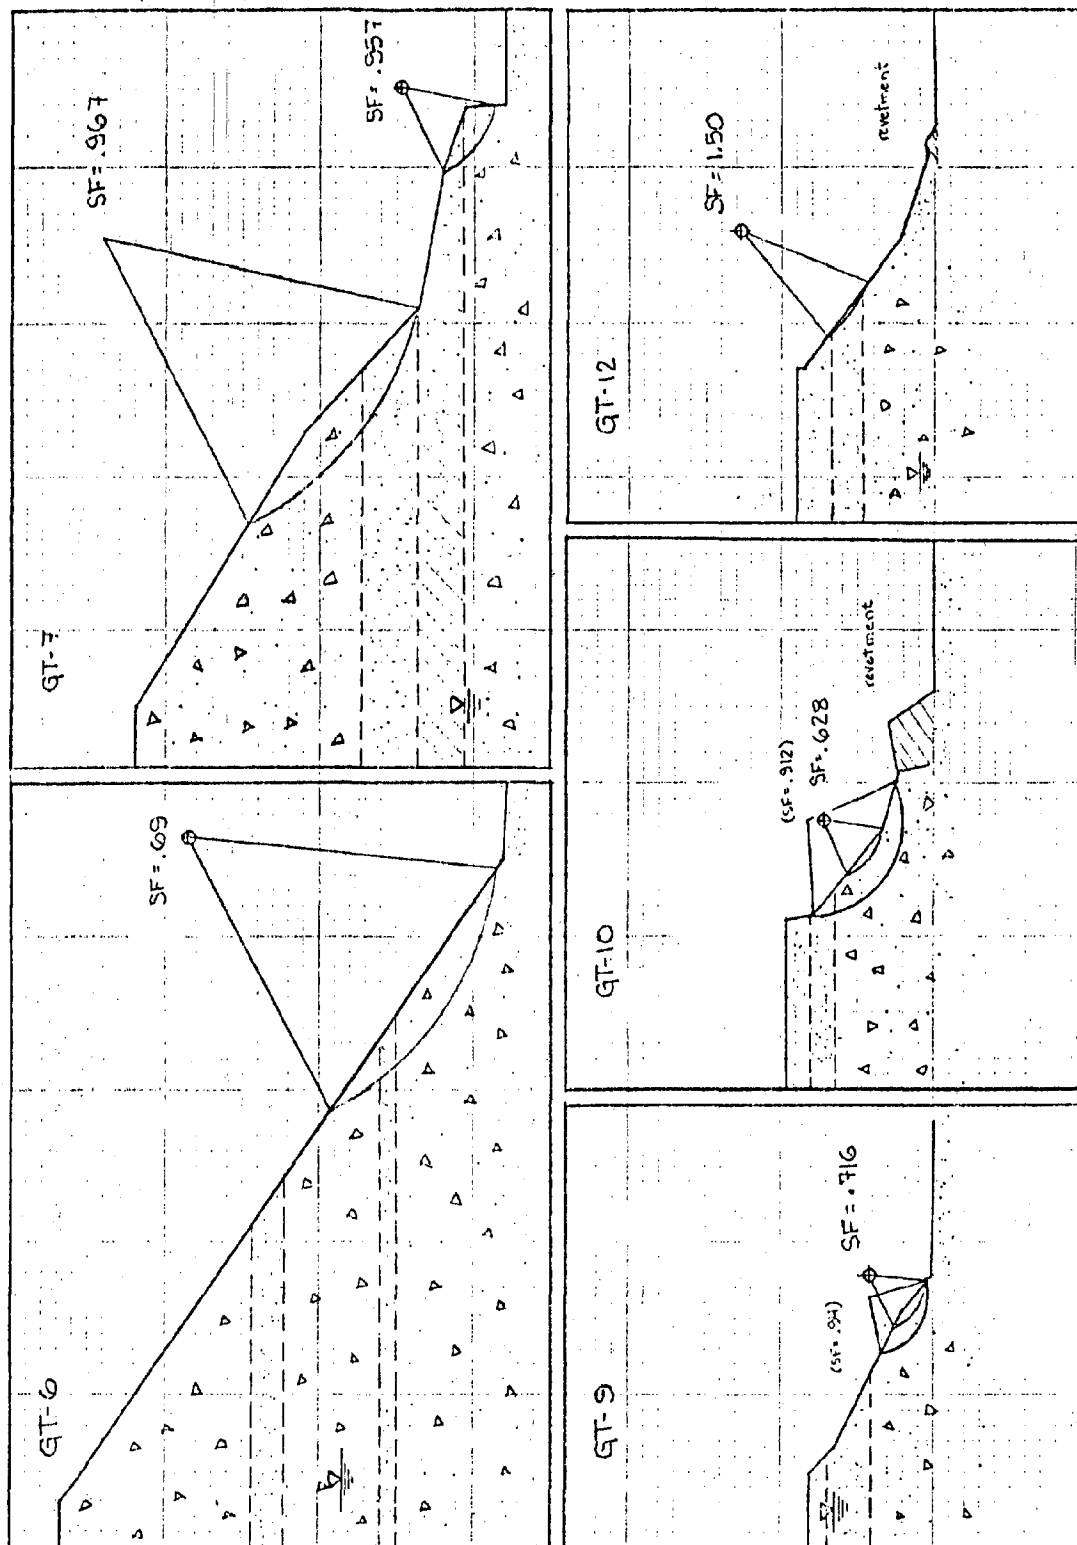
Figure 91. Profiles at geotechnical sites showing critical failure circles. See Fig. 94 for meaning of symbols.

Raising the groundwater table decreases the stability of the bluff, while increasing the size of the failure circle in proportion to the increase in the height of the groundwater table. The profile at borehole GT-6 (Fig. 91) shows the water level at about one-third of the height of the bluff, with a Safety Factor of 0.69; Profile A in Fig. 93, with approximately the same slope angle, and a slightly higher ϕ' , has a groundwater level at about $\frac{3}{4}$ H, with a Safety Factor of only 0.64.

The profile at borehole GT-6 (Fig. 91), and Profile C (Fig. 93) both have low-angle slopes with 100% vegetation. At this angle, the critical criterion is of greatest concern, and the effects of the vegetation, and actual groundwater levels must be taken into account to assess the ultimate stability of the bluff. A series of progressive shallow slides may be expected.

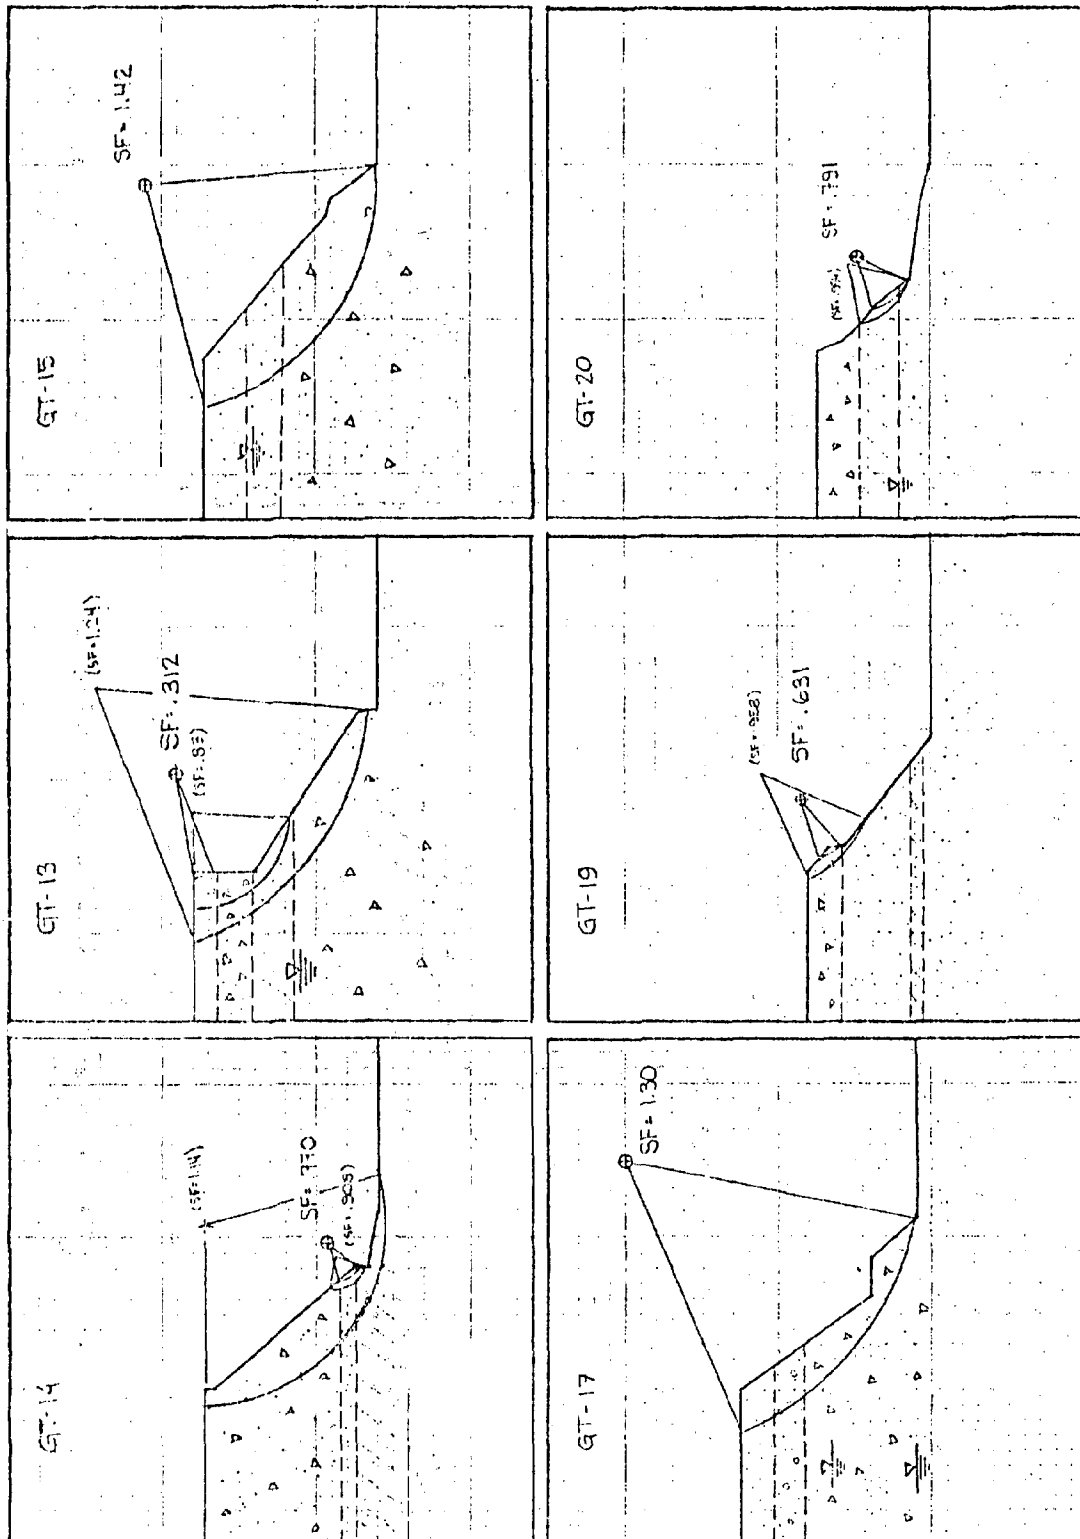
Figure 92. Profiles at geotechnical sites showing critical failure circles. See Fig. 94 for meaning of symbols.

When a cohesive layer in the upper part of a slope overlies a non-cohesive layer, there is little effect on the critical failure circle in the lower part of the bluff. Therefore, sloughing of the lower material is likely, undercutting the toe of the bluff. The stability of the whole bluff is, however, much greater, so that typical failure circles are deep-seated with higher Safety Factors, as shown in Profiles I (Fig. 93) and GT-14 (Fig. 92).
